GROUP
ChassisNUMBER
010MODEL
SorentoDATE
December 2002

Technical Service Bulletin

SUBJECT**Sorento EX Steering Feel**

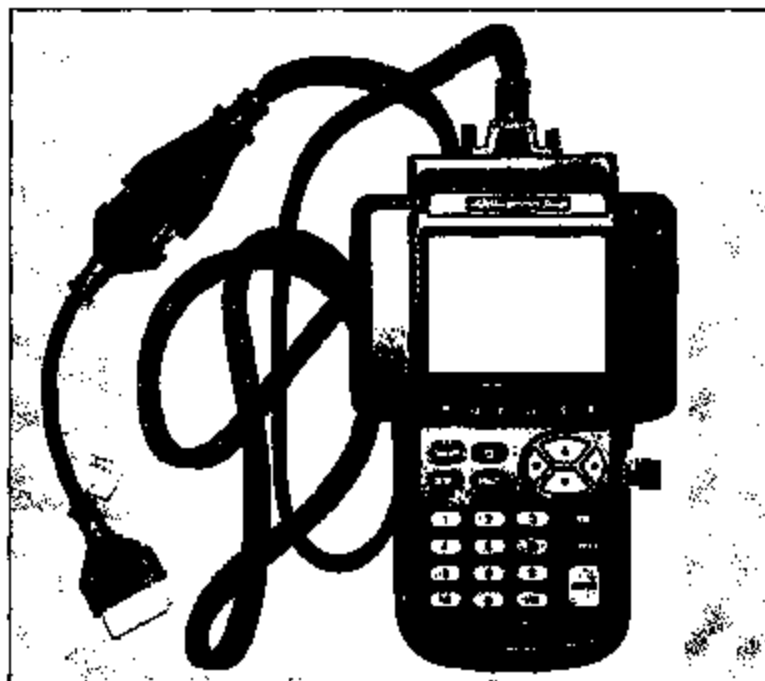
This bulletin provides information relating to an Electronic Power Steering (EPS) logic change to improve steering feel. EPS is the vehicle speed sensing type power steering used in Sorento EX models.

From 10/15/02 production, the EPS software logic was revised to increase steering effort at higher vehicle speeds to improve steering feel.

For 2003MY Sorento EX vehicles produced before 10/15/02 with complaints of light steering feel at high speeds, reprogramming software has been made available for the Hi-Scan Pro for use as a field fix.

Refer to the inspection and reprogramming procedures outlined in the following pages.
